DIRECTOR OF SHIP MATERIAL

JOINT TASK FORCE ONE

FINAL REPORT

FOR TESTS ABLE AND BAKER

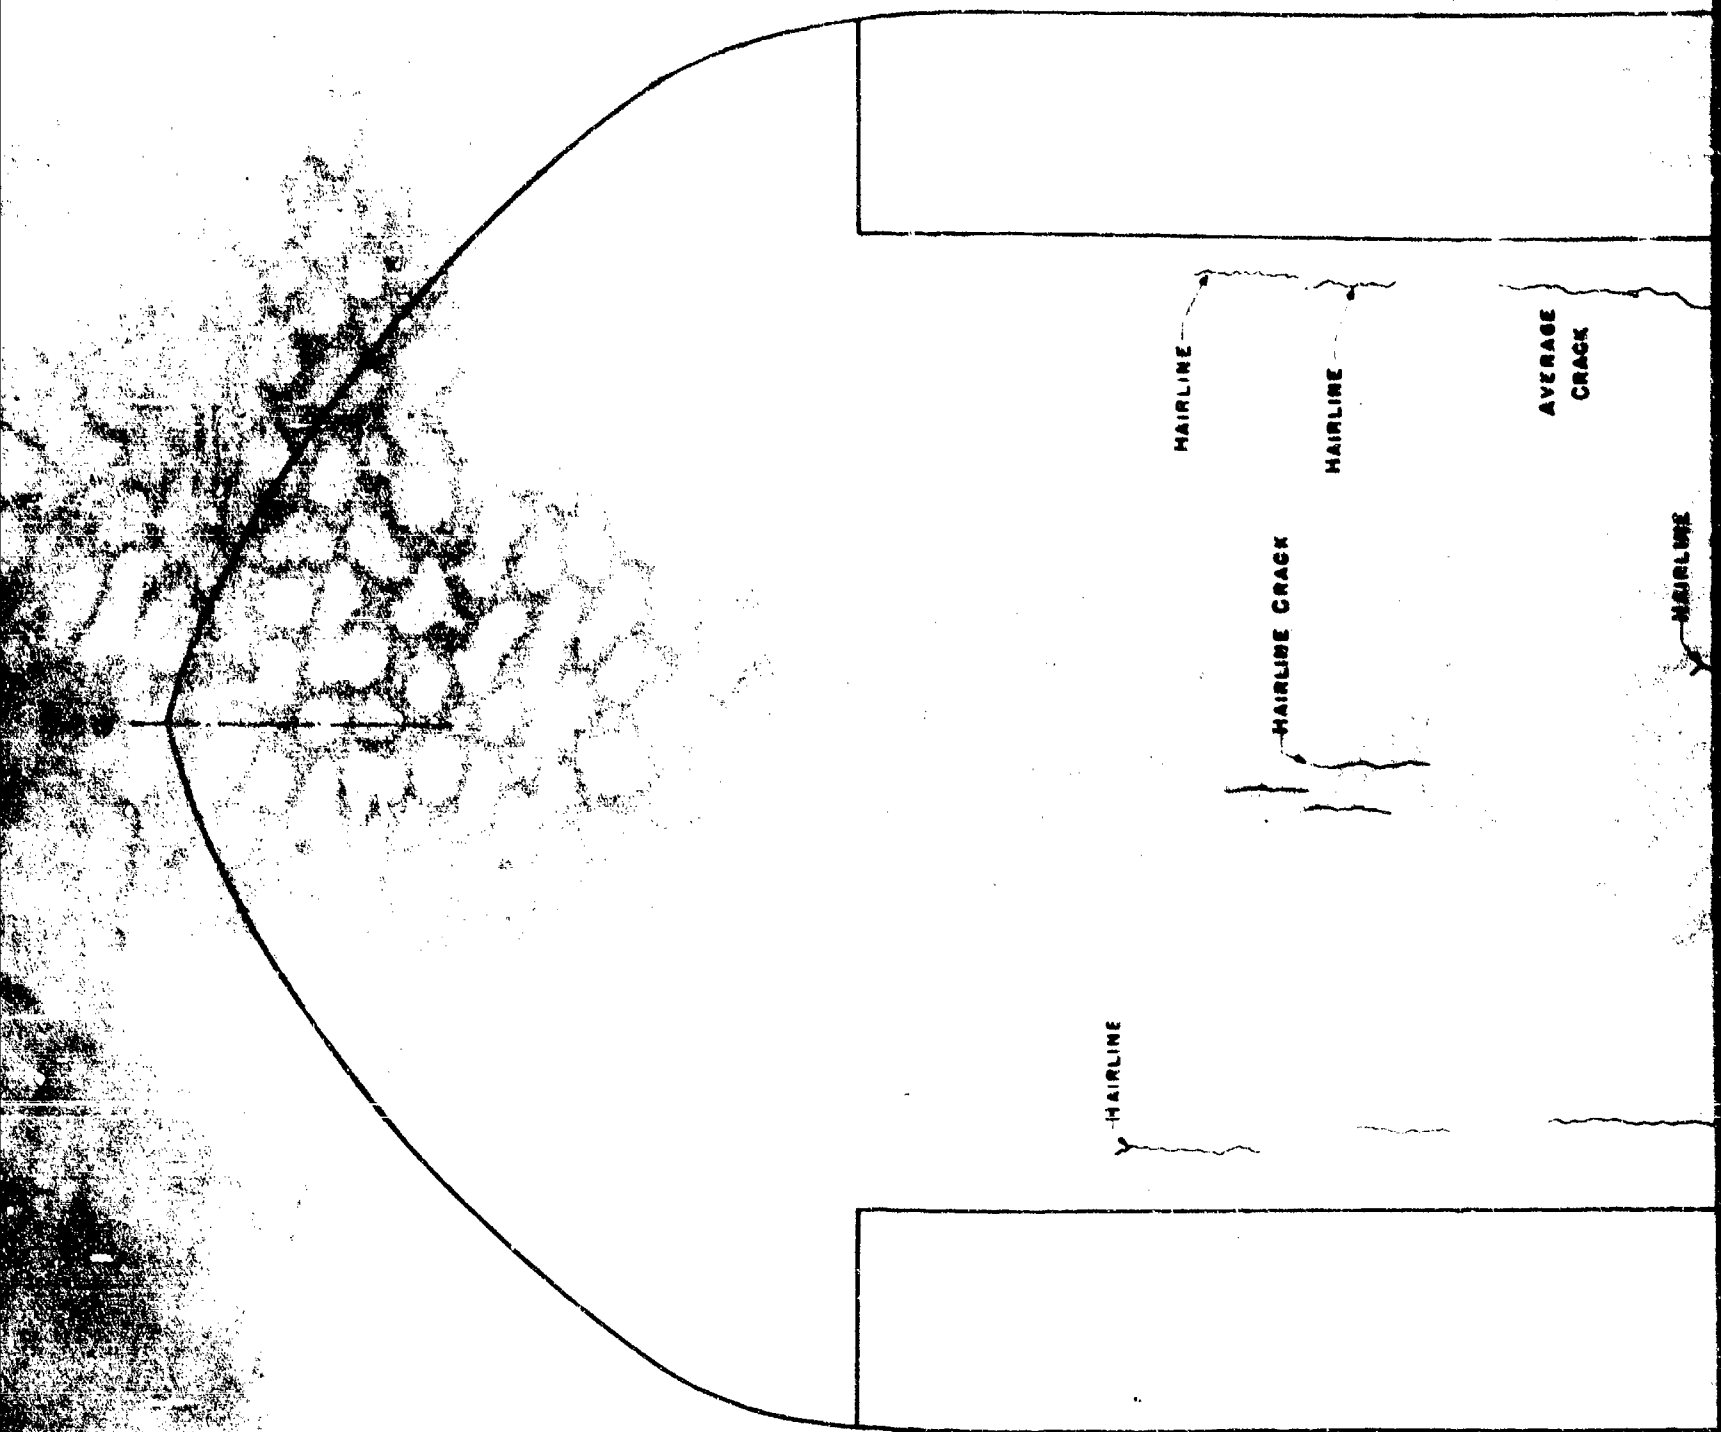
ARDC - 13
CRACK SURVEY AFTER TEST ABLE

DOCK FLOOR "C" DECK LEVEL

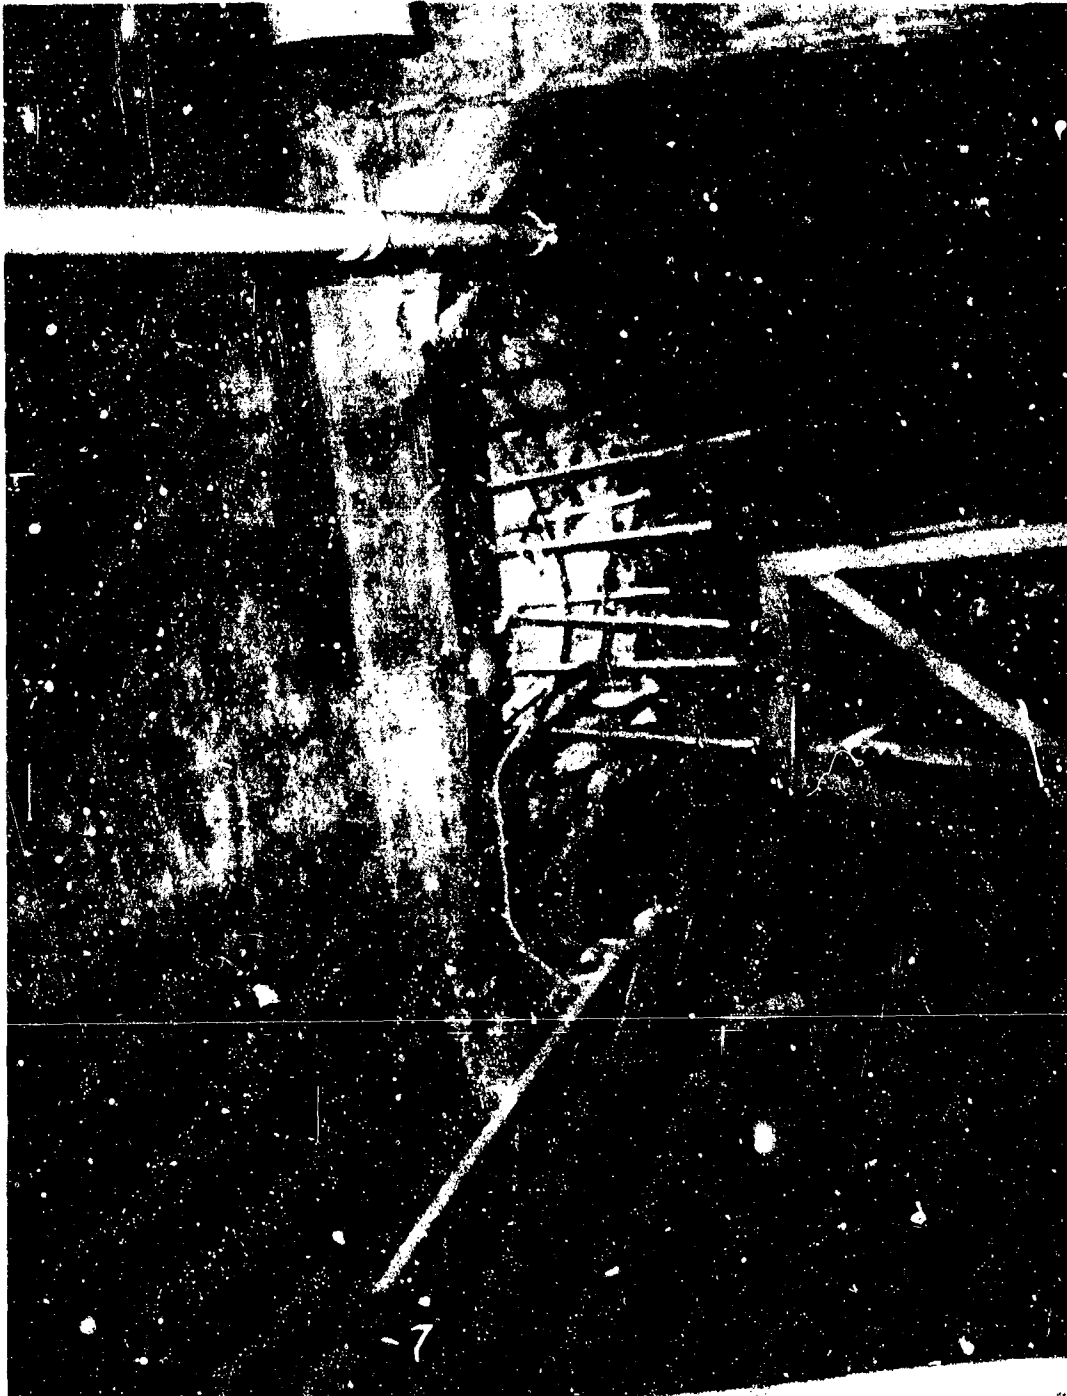
Frames 12 and 13 - Starboard Wing Wall - Facing Forward
